## Barwonside

240 Gully Road, Ceres

Heritage Study/Consultant City of Greater Geelong - Ceres Heritage Citations Project, Dr David Rowe, 2018;

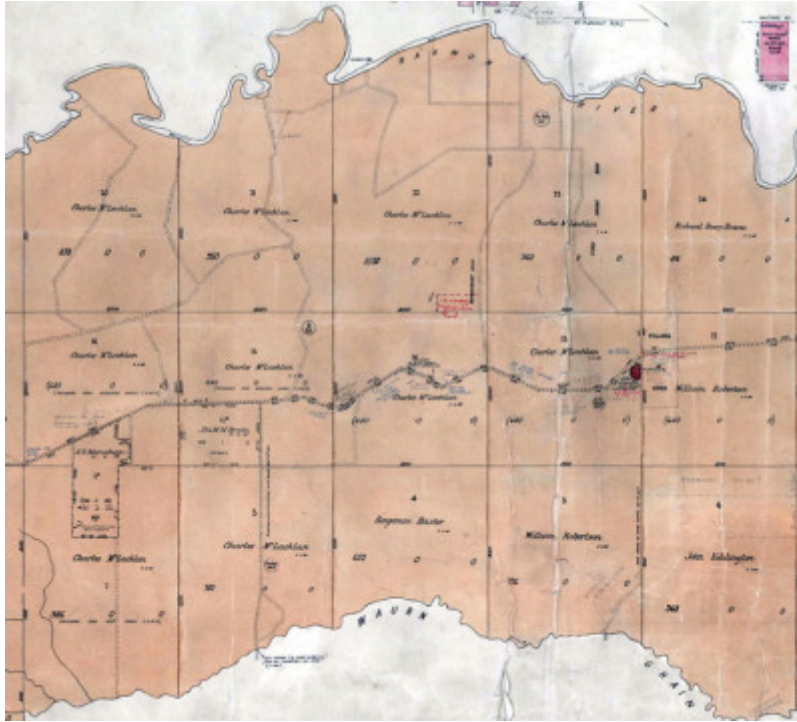
Figure 1: Part Barrabool Parish Plan, Dept of Lands & Survey, Melbourne, March 1946, showing land sections in the Barrabool Hills, including Ceres. Source: VPRS 16171, Public Record Office Victoria.

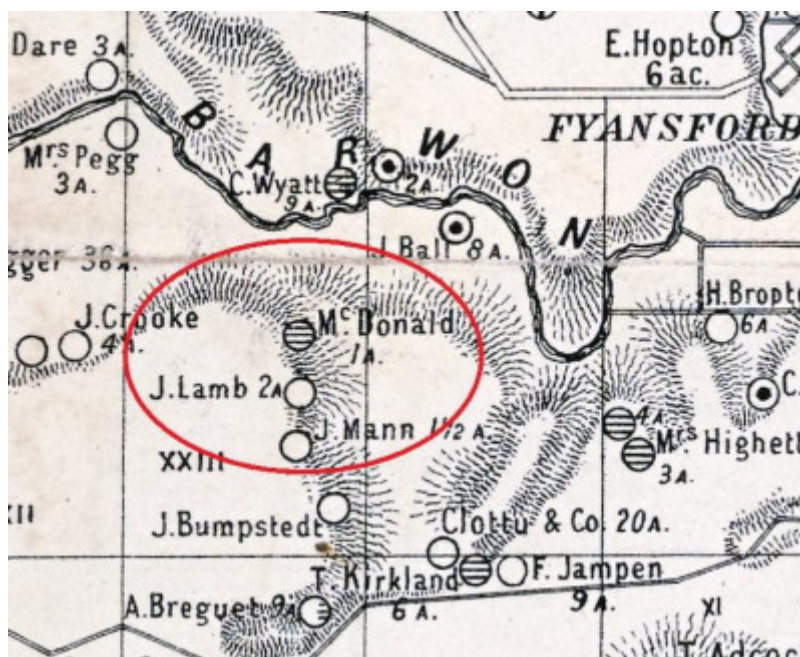
Figure 2: A. McWilliams, Plan of the Barrabool Parish, 1861, showing Robert McDonald's 'Barwonside' (circled). The small red squares represent the buildings on the property. Source: Jennifer Bantow, National Trust of Australia (Victoria) Geelong & Reg

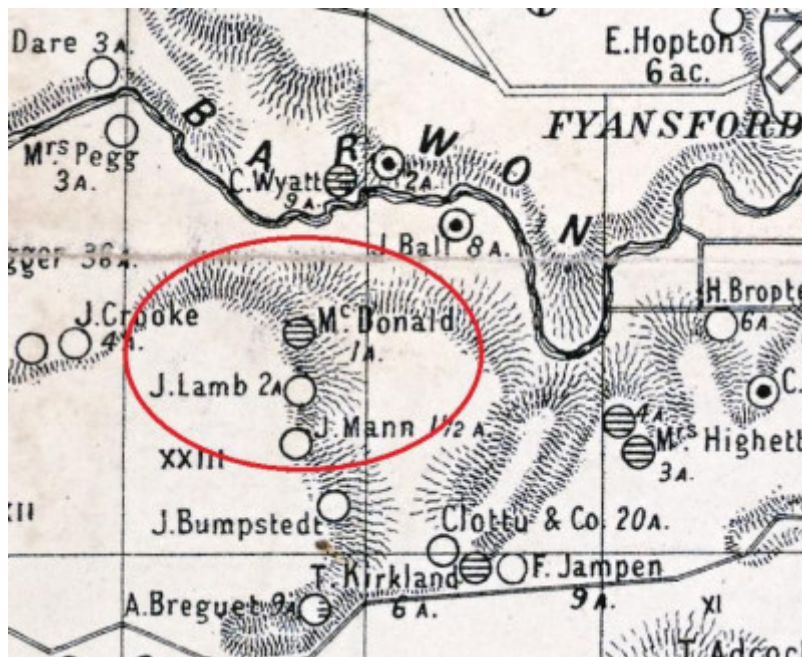
Figure 3: S.B. Bonney, Plan showing the Vineyards of the Geelong District, 22 September 1879. The blank circles represented healthy vineyards, the circles with horizontal lines represented vineyards that were not diseased but neglected, the circles with b
