Erinvale

285 Gully Road, Ceres

Heritage Study/Consultant City of Greater Geelong - Ceres Heritage Citations Project, Dr David Rowe, 2018;

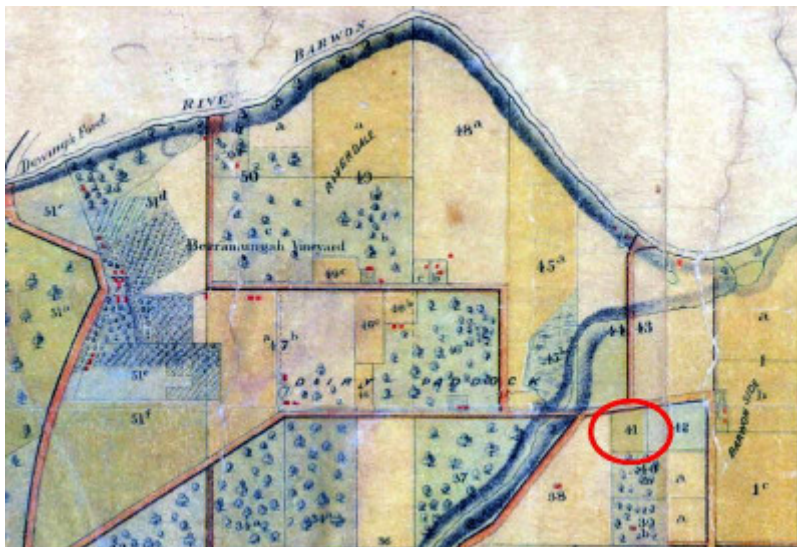
Fig 1 Barrabool Parish Plan PROV VPRS16171 part.jpg

Figure 2: A. McWilliams, Plan of the Barrabool Parish, 1861, showing Thomas Heard's 'Riverdale' property (top-centre) and lots 41 (purchased 1851) and lot 38 (purchased 1859).
Source: Jennifer Bantow, National Trust of Australia (Victoria) Geelong & R
