Former Wesleyan Church

Former Wesleyan Church and Sunday School

17 McCann Street CERES, GREATER GEELONG CITY

Heritage Study/Consultant City of Greater Geelong - Ceres Heritage Citations Project, Dr David Rowe, 2018;

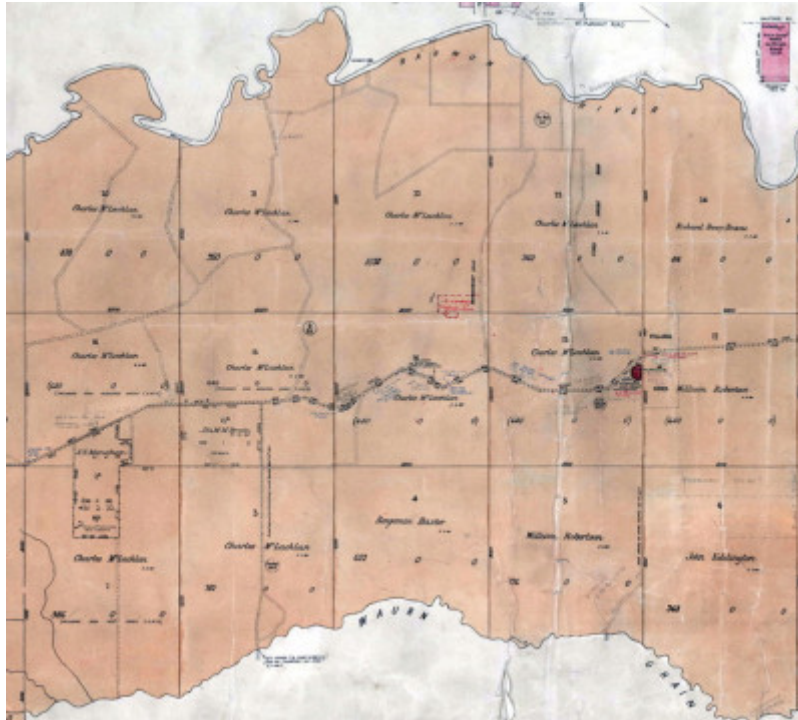
Figure 1: Part Barrabool Parish Plan, Dept of Lands & Survey, Melbourne, March 1946, showing land sections in the Barrabool Hills, including Ceres. Source: VPRS 16171, Public Record Office Victoria
