Erinvale

285 Gully Road, Ceres

Statement of Significance

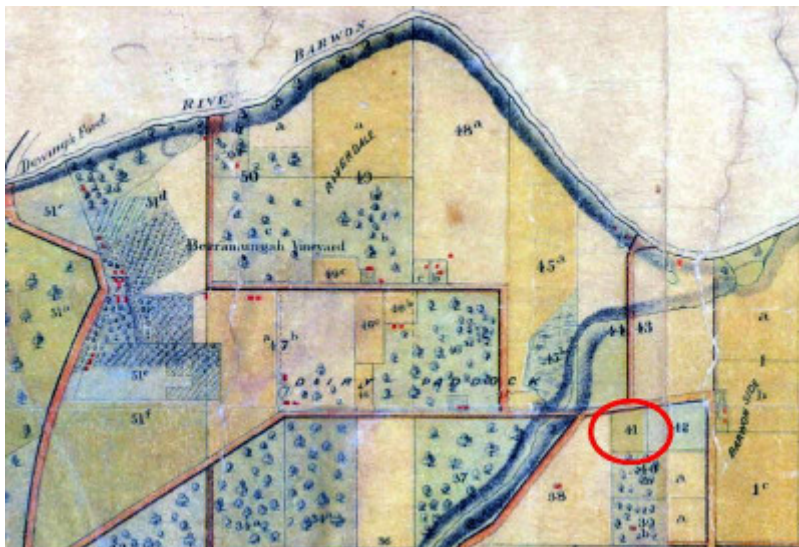
Fig 1 Barrabool Parish Plan PROV VPRS16171 part.jpg

Figure 2: A. McWilliams, Plan of the Barrabool Parish, 1861, showing Thomas Heard's 'Riverdale' property (top-centre) and lots 41 (purchased 1851) and lot 38 (purchased 1859).
Source: Jennifer Bantow, National Trust of Australia (Victoria) Geelong & R
