## Barkly St and Humffray St Precinct

Barkly St and Humffray St and Porter St and Steinfeld St and Eastwood St BAKERY HILL, BALLARAT CITY

Ballarat - Ballarat Heritage Precincts Study, Dr David Rowe and Wendy Jacobs,  
2006;

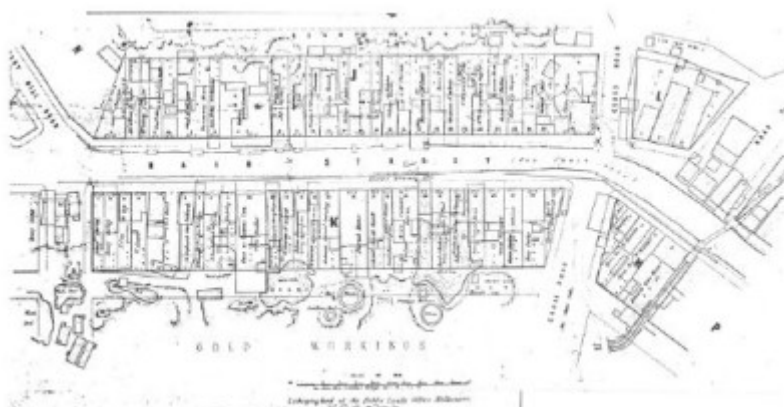
Figure 2.04: Part of Revised Plan of Blocks J, K, L & M, Main Street Ballarat, 1904 copy of original lithograph, February 1858, showing concentration of buildings along Main Street, buildings overlapping into present day Porter Street, and mining equi

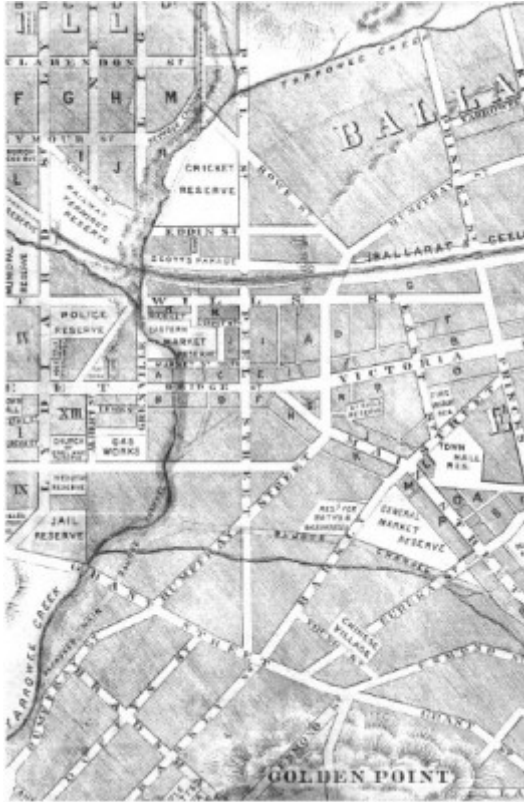
Figure 2.03: Portion of Plan of Ballarat Municipalities, engraved after the latest Government Surveys by H Deutsch, Ballarat, n.d. estimated 1860s, showing ?Reserve for Baths & Washhouses? in the south east section of the precinct, and the ?Sludge Cha

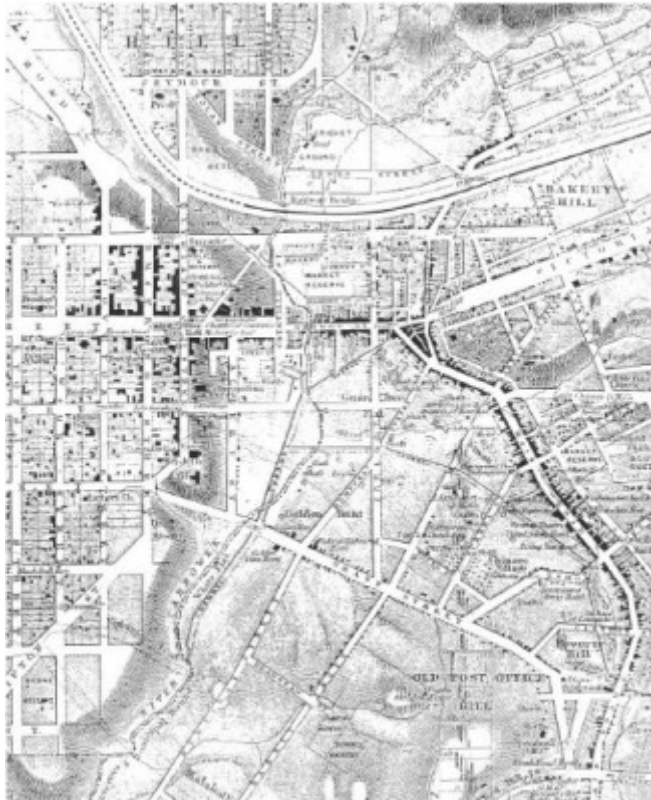
Figure 2.01: Portion of map of Ballarat, J Brache, October 21, 1861, showing mine shafts in the precinct area bounded by Main Road, Humffray Street, Barkly Street and the Channel. The Red Streak Lead is also identified on this map. -

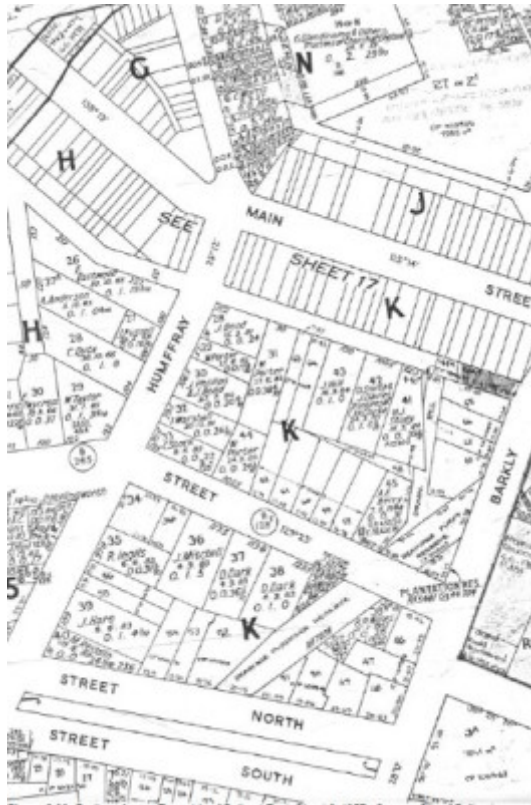
Figure 2.09: Portion of map, Township of Ballarat East, Sheet 6, 1957. -

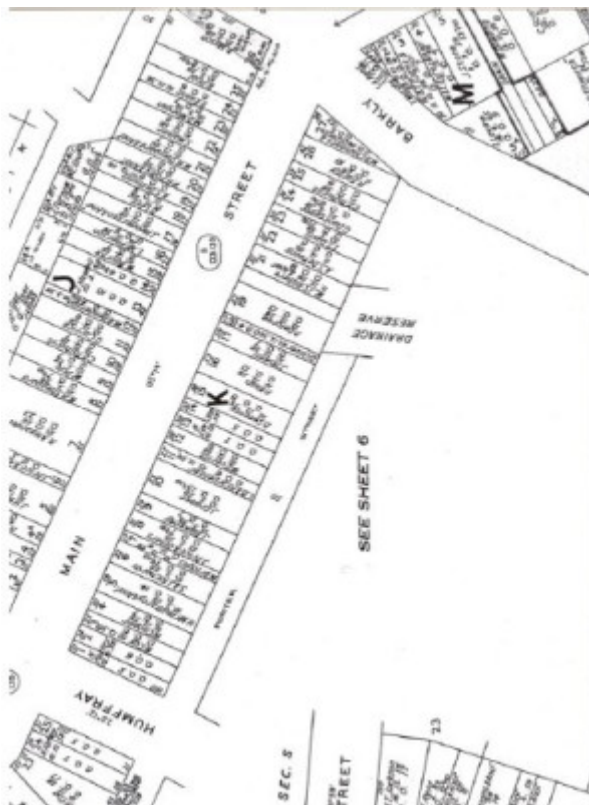
Figure 2.10: Portion of map, Township of Ballarat East, Sheet 17, 1957. Source: City of Ballarat -

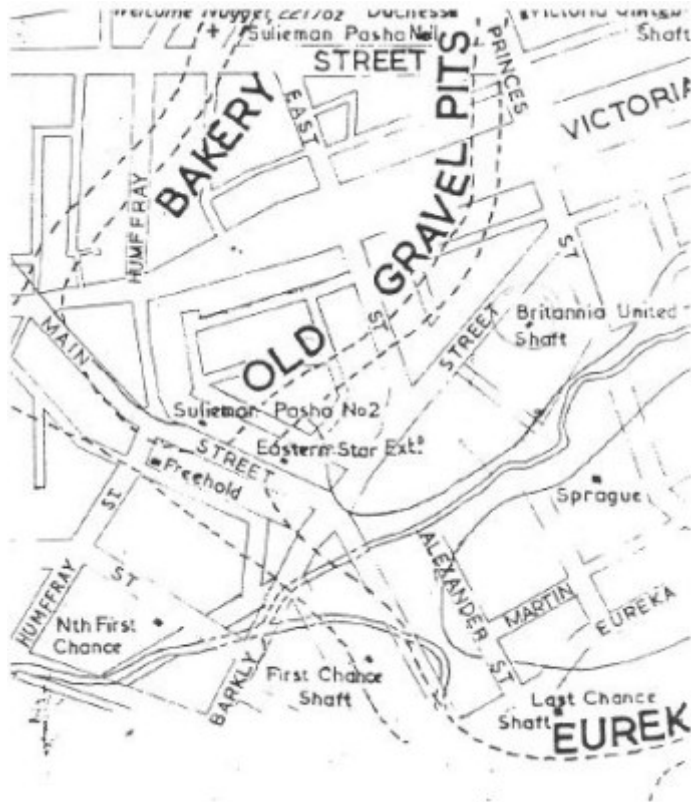
Figure 2.06: Portion of Ballarat Gold Field Map, enlarged from Geological and Topographical Survey, 1917, by W Baragwanath, showing ?Nth First Chance? mine below present day Eastwood Street in the precinct. -

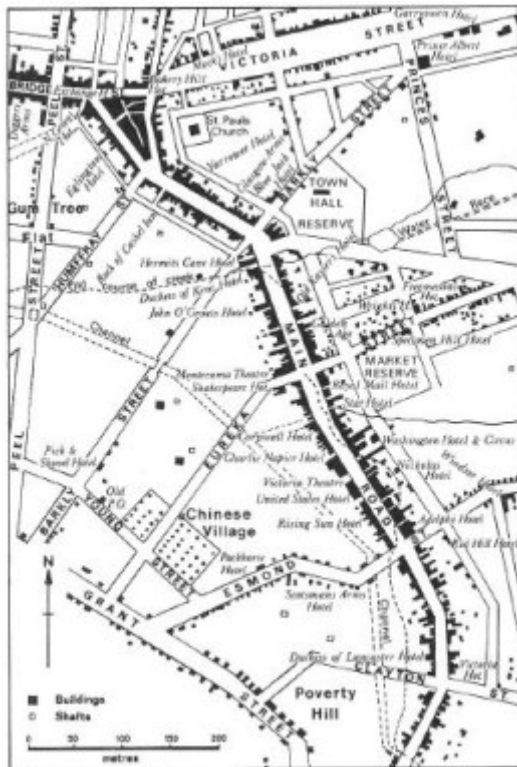
Main Street in 1861

Figure 2.02: Map of Main Road in 1861 showing concentration of buildings along Main Road, two buildings in the east of the precinct, two mine shafts, the ?Old course of creek?, and the Channel along Steinfeld Street. -

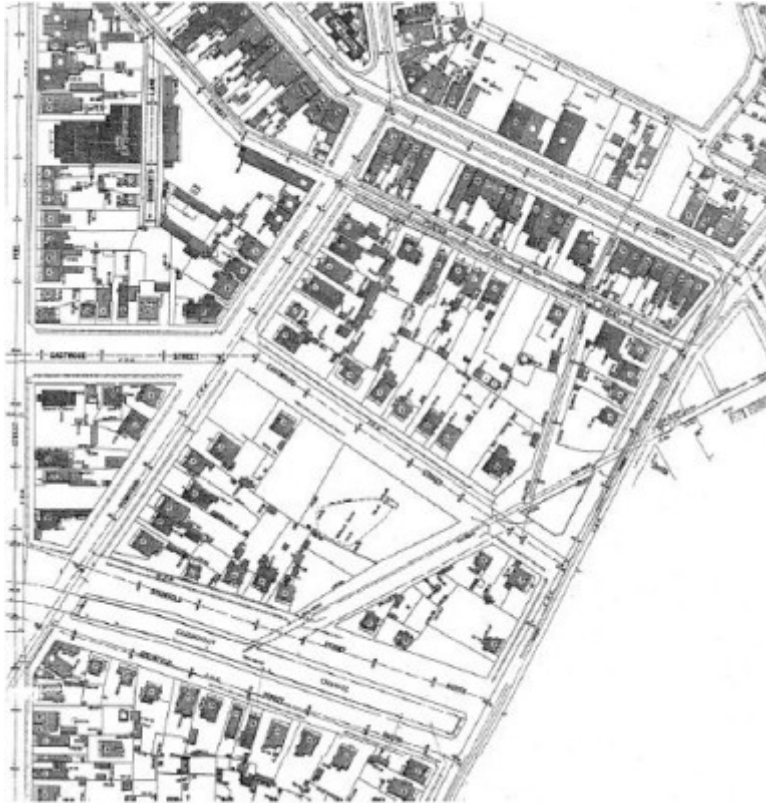
Figure 2.07: Ballarat Sewerage Authority Plan, December 7, 1926, showing ?Shaft? and ?Mullock Dump? at the site of the North First Chance mine.

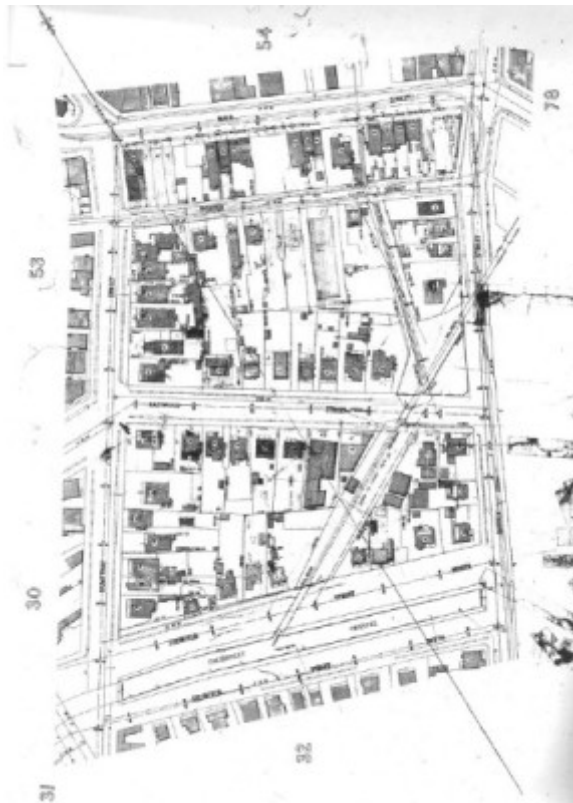
Figure 2.08: Ballarat Sewerage Authority Plan, revised March 1927 (with later additions). This plans shows that the mullock dump and shaft had been replaced by houses. However, it appears that these houses may have been added later to this early plan. -
