Barkly St and Humffray St Precinct

Barkly St and Humffray St and Porter St and Steinfeld St and Eastwood St BAKERY HILL, BALLARAT CITY

Ballarat - Ballarat Heritage Precincts Study, Dr David Rowe and Wendy Jacobs,
2006;

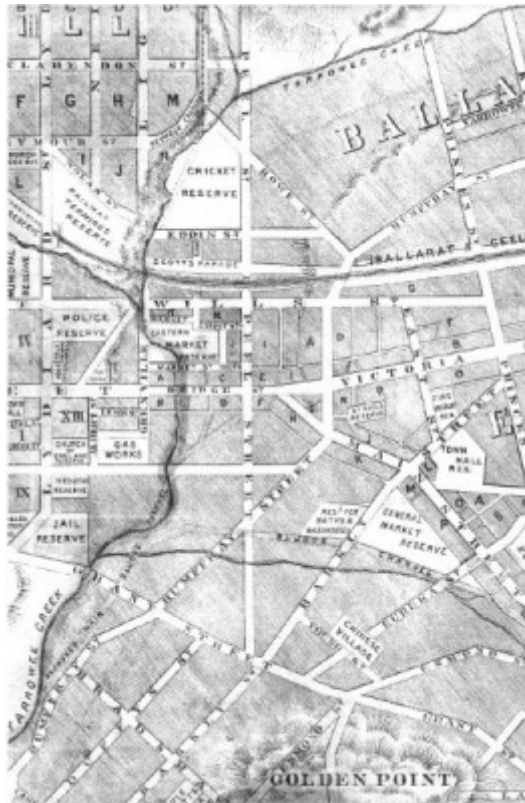
Figure 2.04: Part of Revised Plan of Blocks J, K, L & M, Main Street Ballarat, 1904 copy of original lithograph, February 1858, showing concentration of buildings along Main Street, buildings overlapping into present day Porter Street, and mining equi

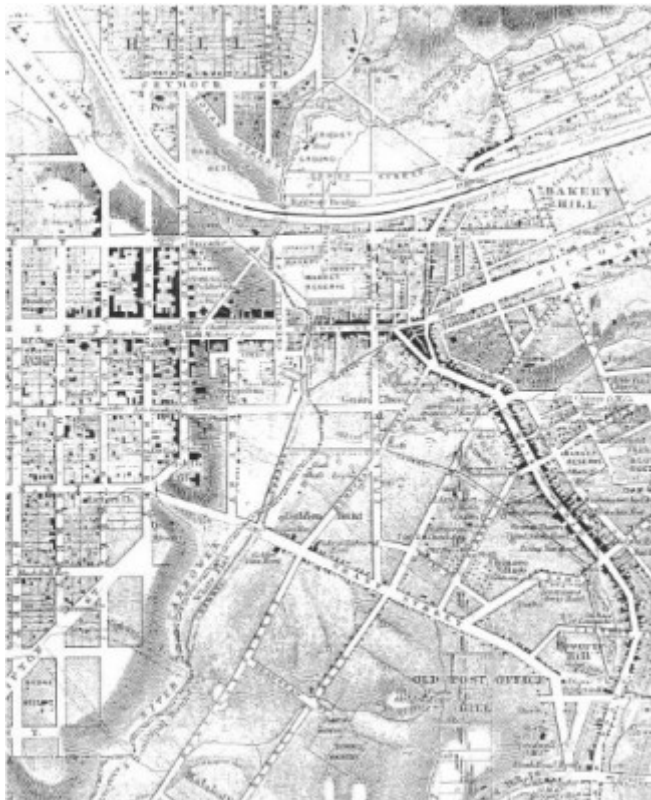
Figure 2.03: Portion of Plan of Ballarat Municipalities, engraved after the latest Government Surveys by H Deutsch, Ballarat, n.d. estimated 1860s, showing ?Reserve for Baths & Washhouses? in the south east section of the precinct, and the ?Sludge Cha

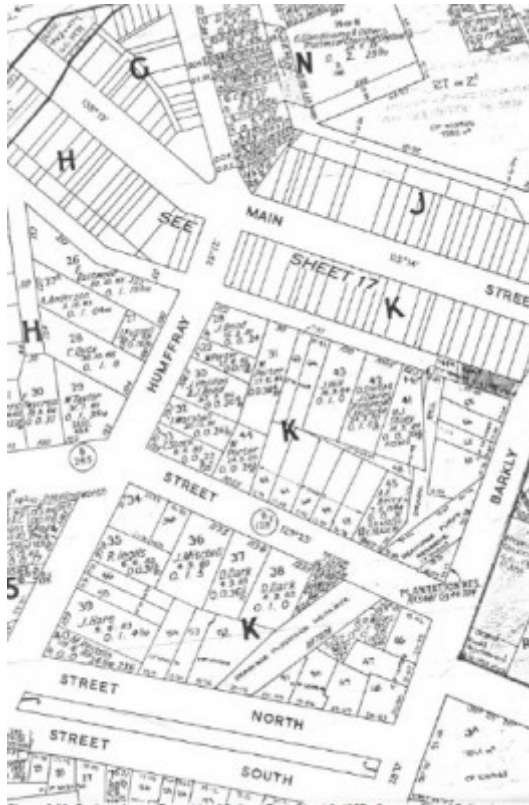
Figure 2.01: Portion of map of Ballarat, J Brache, October 21, 1861, showing mine shafts in the precinct area bounded by Main Road, Humffray Street, Barkly Street and the Channel. The Red Streak Lead is also identified on this map. -

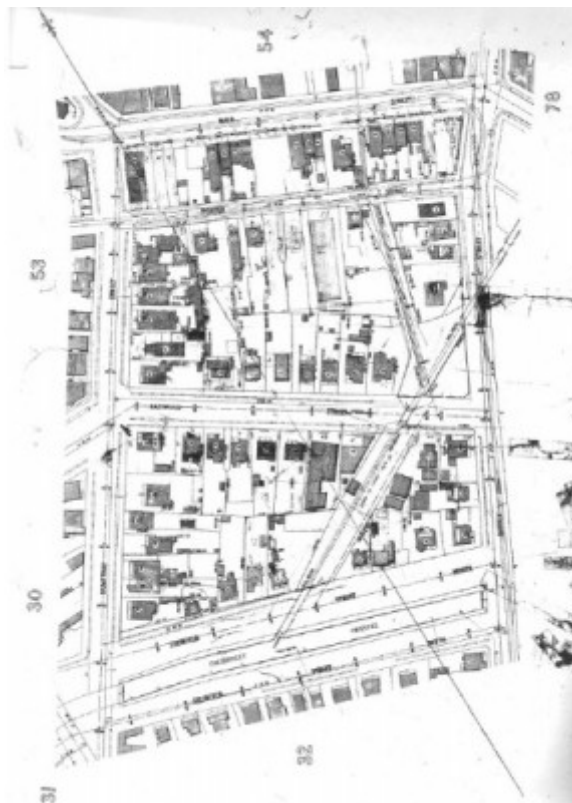
Figure 2.07: Ballarat Sewerage Authority Plan, December 7, 1926, showing ?Shaft? and ?Mullock Dump? at the site of the North First Chance mine.
