26 Mercer Street, Queenscliff

Statement of Significance

Extract from the 2009 study

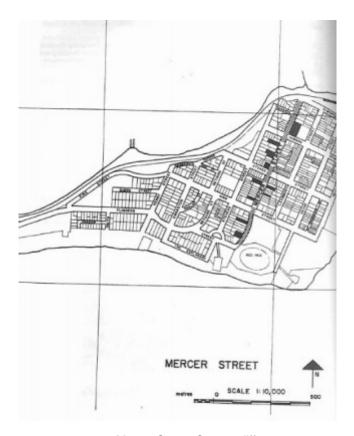
26 Mercer Street is a large hip-roofed timber dwelling. It has been stripped of its concave-roof verandah, and the window and door openings, on the east facade, have been sheeted over.

No. 26 Mercer Street is a large single-storey weatherboard dwelling with slate-clad ('M' form) hips to the roof and large chimney stacks. It has a wide frontage and deep setback to the street. Recent works have included the construction of a long concave verandah with a cruciform balustrade detail. It is not known if this is based on the original form. The window and door openings on the east facade, which had previously been sheeted over, have also been re-opened. To the rear of the building is a flat roof extension connected to the main building via a small
