Castlemaine Drill Hall

DRILL HALL SOHE 2008

H0683 H0683 plan

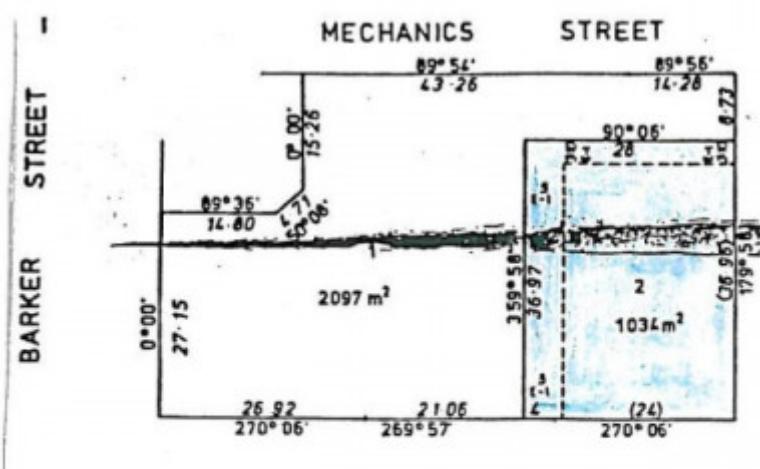
LYTTLETON STREET
STREET
BARKER STREET
MECHANICS STREET

LENGTHS ARE IN METRES
AREAS (IF SHOWN) ARE IN SQUARE METRES (m²)

The whole of the land and all the buildings entered in Certificate of Title Vol. 9512 Folio 200 to the extent marked on the plan held by the Minister for Planning and Environment.
