Ceres Primary School

Ceres Primary School, 605 Barrabool Road, Ceres

Heritage Study/Consultant City of Greater Geelong - Ceres Heritage Citations Project, Dr David Rowe, 2018;

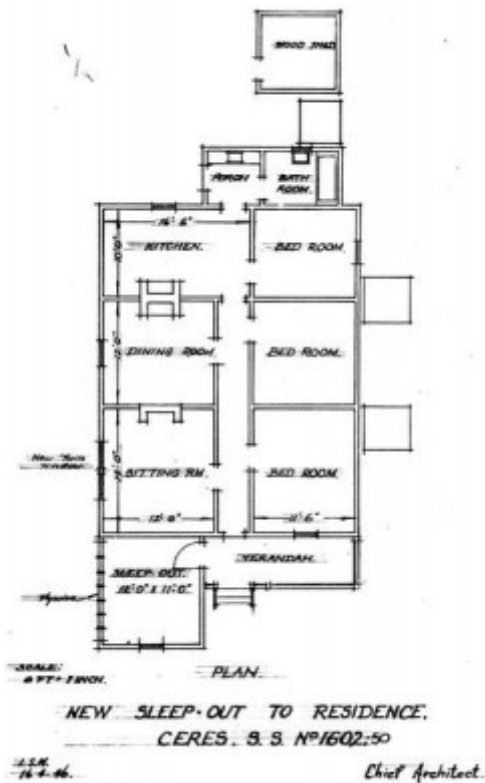
Figure 5: Proposed sleep out addition to Teacher's Residence, 16 April 1946 Source: Drawing SS 1602.50, Public Record Office Victoria.

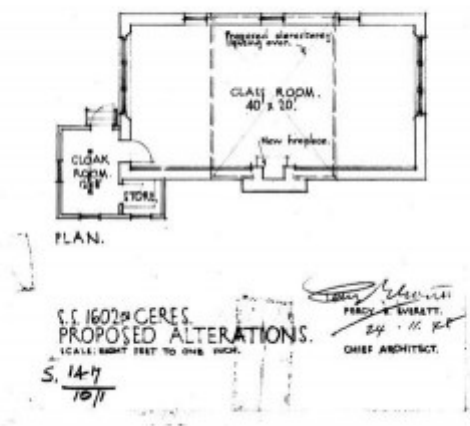
Figure 8: P. Everett, Proposed Alterations to Ceres School ? Floor Plan, 24 November 1948 Source: Drawing SS 1602.51, Public Record Office Victoria.

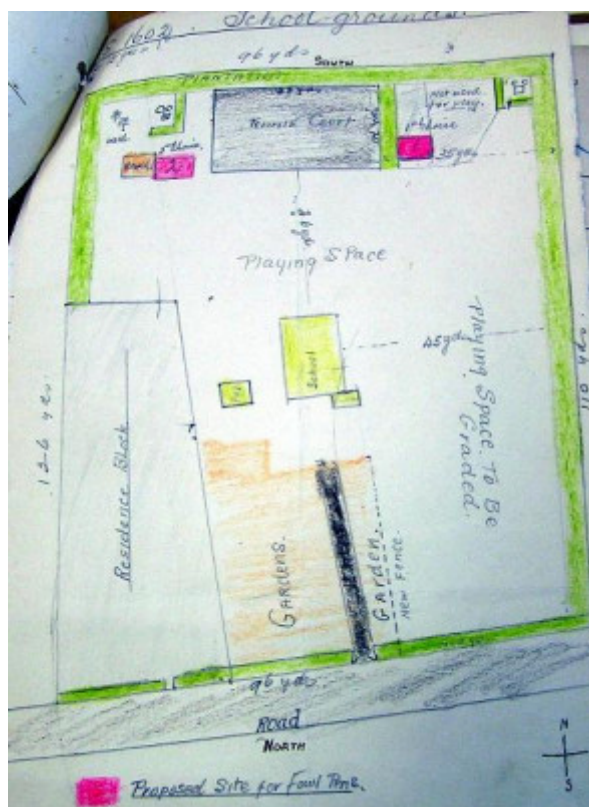
Figure 18 Schematic Site Plan of the Ceres State School, 1946. Source: Public Building file, VPRS 795/P0 Unit 2287 Public Record Office Victoria.

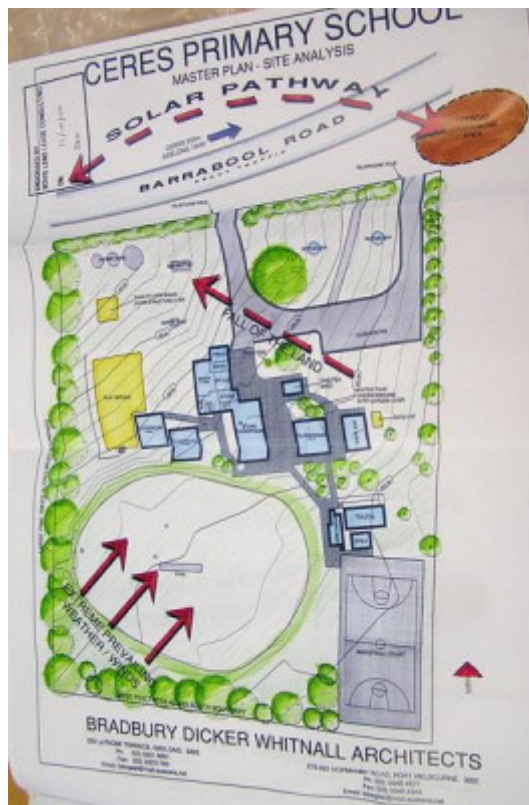
Figure 20: Bradbury Dicker Whitnall Architects, Ceres State School Site Analysis, 2000 .
 Source: Public Building file VPRS 16963/P1 Unit 293 Public Record Office Victoria.
