Wallingford

City of Darebin Heritage
Review 2000

36 James Street NORTHCOTE, Darebin City

HO54

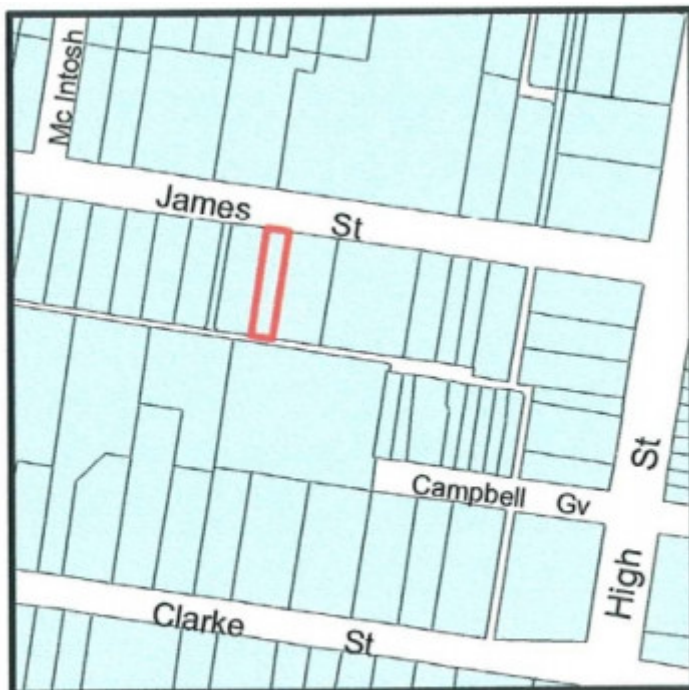
Wallingford is distinctive for its elaborate ornamentation including diaper patterned polychrome brickwork and ceramic tiled frieze. The fine craftsmanship of the house is the result of its owner builder John Timmins, and contributes to the character of the local streetscape.

Wallingford is sited amongst a number of similar face brick houses which are generally of a later vintage. The polychromatic brick house is single fronted with a recessed entrance under a return cast iron bull nose profiled verandah. The verandah floor is of ceramic encaustic tiling, and the three front steps have vermiculated rendered side walls. Further decoration occurs at the sill brackets and the intact render work to the verandah and party walls, including a mask, fluting, vermiculation and panelled foliation. The tall bi-chrome brick chimneys have heavy moulded rendered cappings. The street elevation has diaper patterned brickwork and a glazed ceramic tiled frieze between moulded brick eaves brackets. The hipped slate roof is patterned. Alterations include the replacement of the front fence.
