## HOUSES

City of Darebin Heritage  
Review 2000

1-3 Leonard Street NORTHCOTE, Darebin City

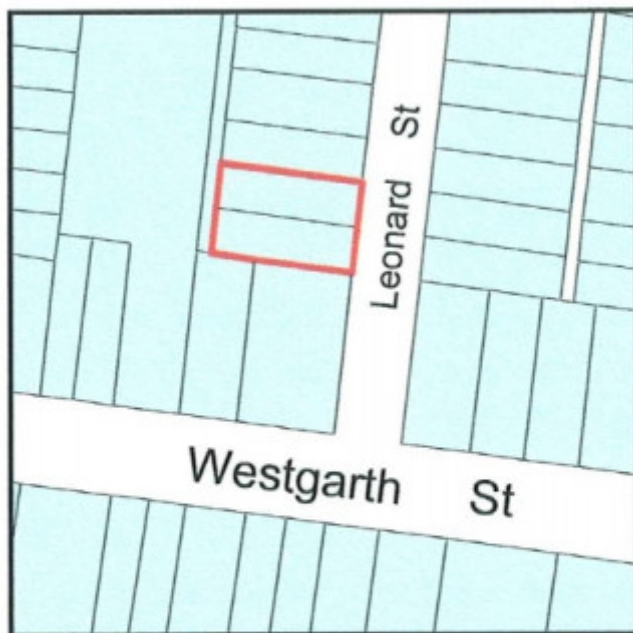
Map Ref: **30 J11**

A Federation period attached pair of dwellings having a common masonry party wall but in other respects being of timber construction with gable ended pavilions either side of a recessed posted verandah with ladder frieze and timber spandrels. There is an unusual band of hung fish scale shingles and a vertical board dado to the pavilions and double hung windows and sun hood.

Condition: Sound. Integrity: Medium, windows part altered, gable ends and verandah ornamentation altered.
