## Residence

185 Roslyn Road, BELMONT Vic 3216 - Property No 237406

## Statement of Significance

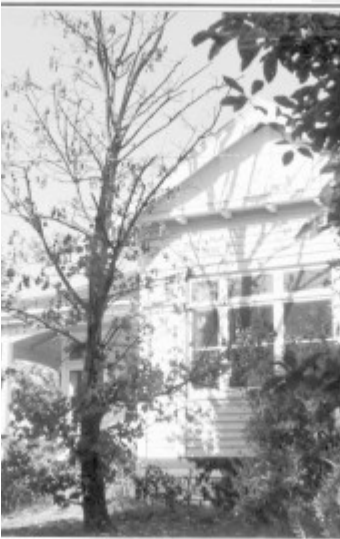
27134 Roslyn Road No 185  
Photo

The single storey, asymmetrical, horizontal weatherboard, Federation style house is characterised by a recessed hipped roof that is extended to form a broken back return verandah, and a minor gable that projects towards the street frontage. These roof forms appear to be clad in painted galvanised corrugated iron. Wide overhangs are a feature of the eaves. The early timber framed double hung windows with frosted glass highlights are arranged as a horizontal bank of four under the projecting gable, and as a corner bay under the verandah.

A feature of the design is the return verandah. It is supported by recent? but appropriate square timber columns with decorative timber brackets.

Early decorative features of the design include the gable infill (brackets, panelling and battening).
