# CALEDONIAN UNION HOTEL (FORMER)

52866 Caledonian Union Hotel former

6011 HENTY HIGHWAY, SANDFORD, GLENELG SHIRE

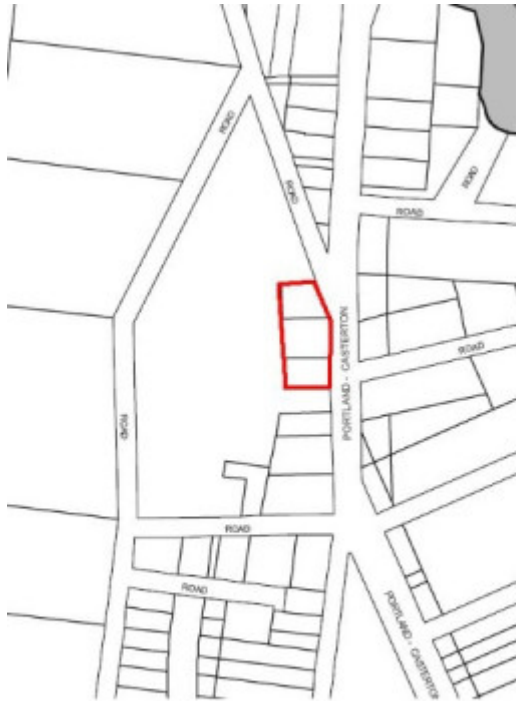
52866 Caledonian Union  
Hotel Sandford whole view

The hotel building is a single storey building with pavilions at either end joined by the central section with a corrugated iron verandah. An early photograph shows the building with one pavilion having a traditional corner entrance to the public bar, and each pavilion with one twelve pane double hung sash window. It is interesting that the north pavilion had a corner entrance, despite the building not being located on a corner as such. The current building appears to have been re-modelled in the nineteenth century, the single window being replaced with a pair of single paned double hung sashes on each pavilion and the bar entrance bricked up. The early photograph shows that each pavillion had an entrance through the joining verandah; both doors survive today. The facade of the central section is largely symmetrical; the original photograph shows a central door flanked by two twelve pane double hung sash windows, with a separate door on the other side of the southern window. The roofs are of corrugated iron. The south pavilion is a simple hip, with the north pavilion roof a canted hip, typical of hotels. The hotel has been modified internally, although the interiors have not been inspected. The building is in fair condition, with substantial evidence of rising damp and cracking in some of the walls.
